Scorpion TMA Post Impact Survey Measurements

TITLE:
TMA Post Impact Measurements and Survey

SIZE B	DRAWING NO. 1086	REV E
------------------	---------------------	-----------------

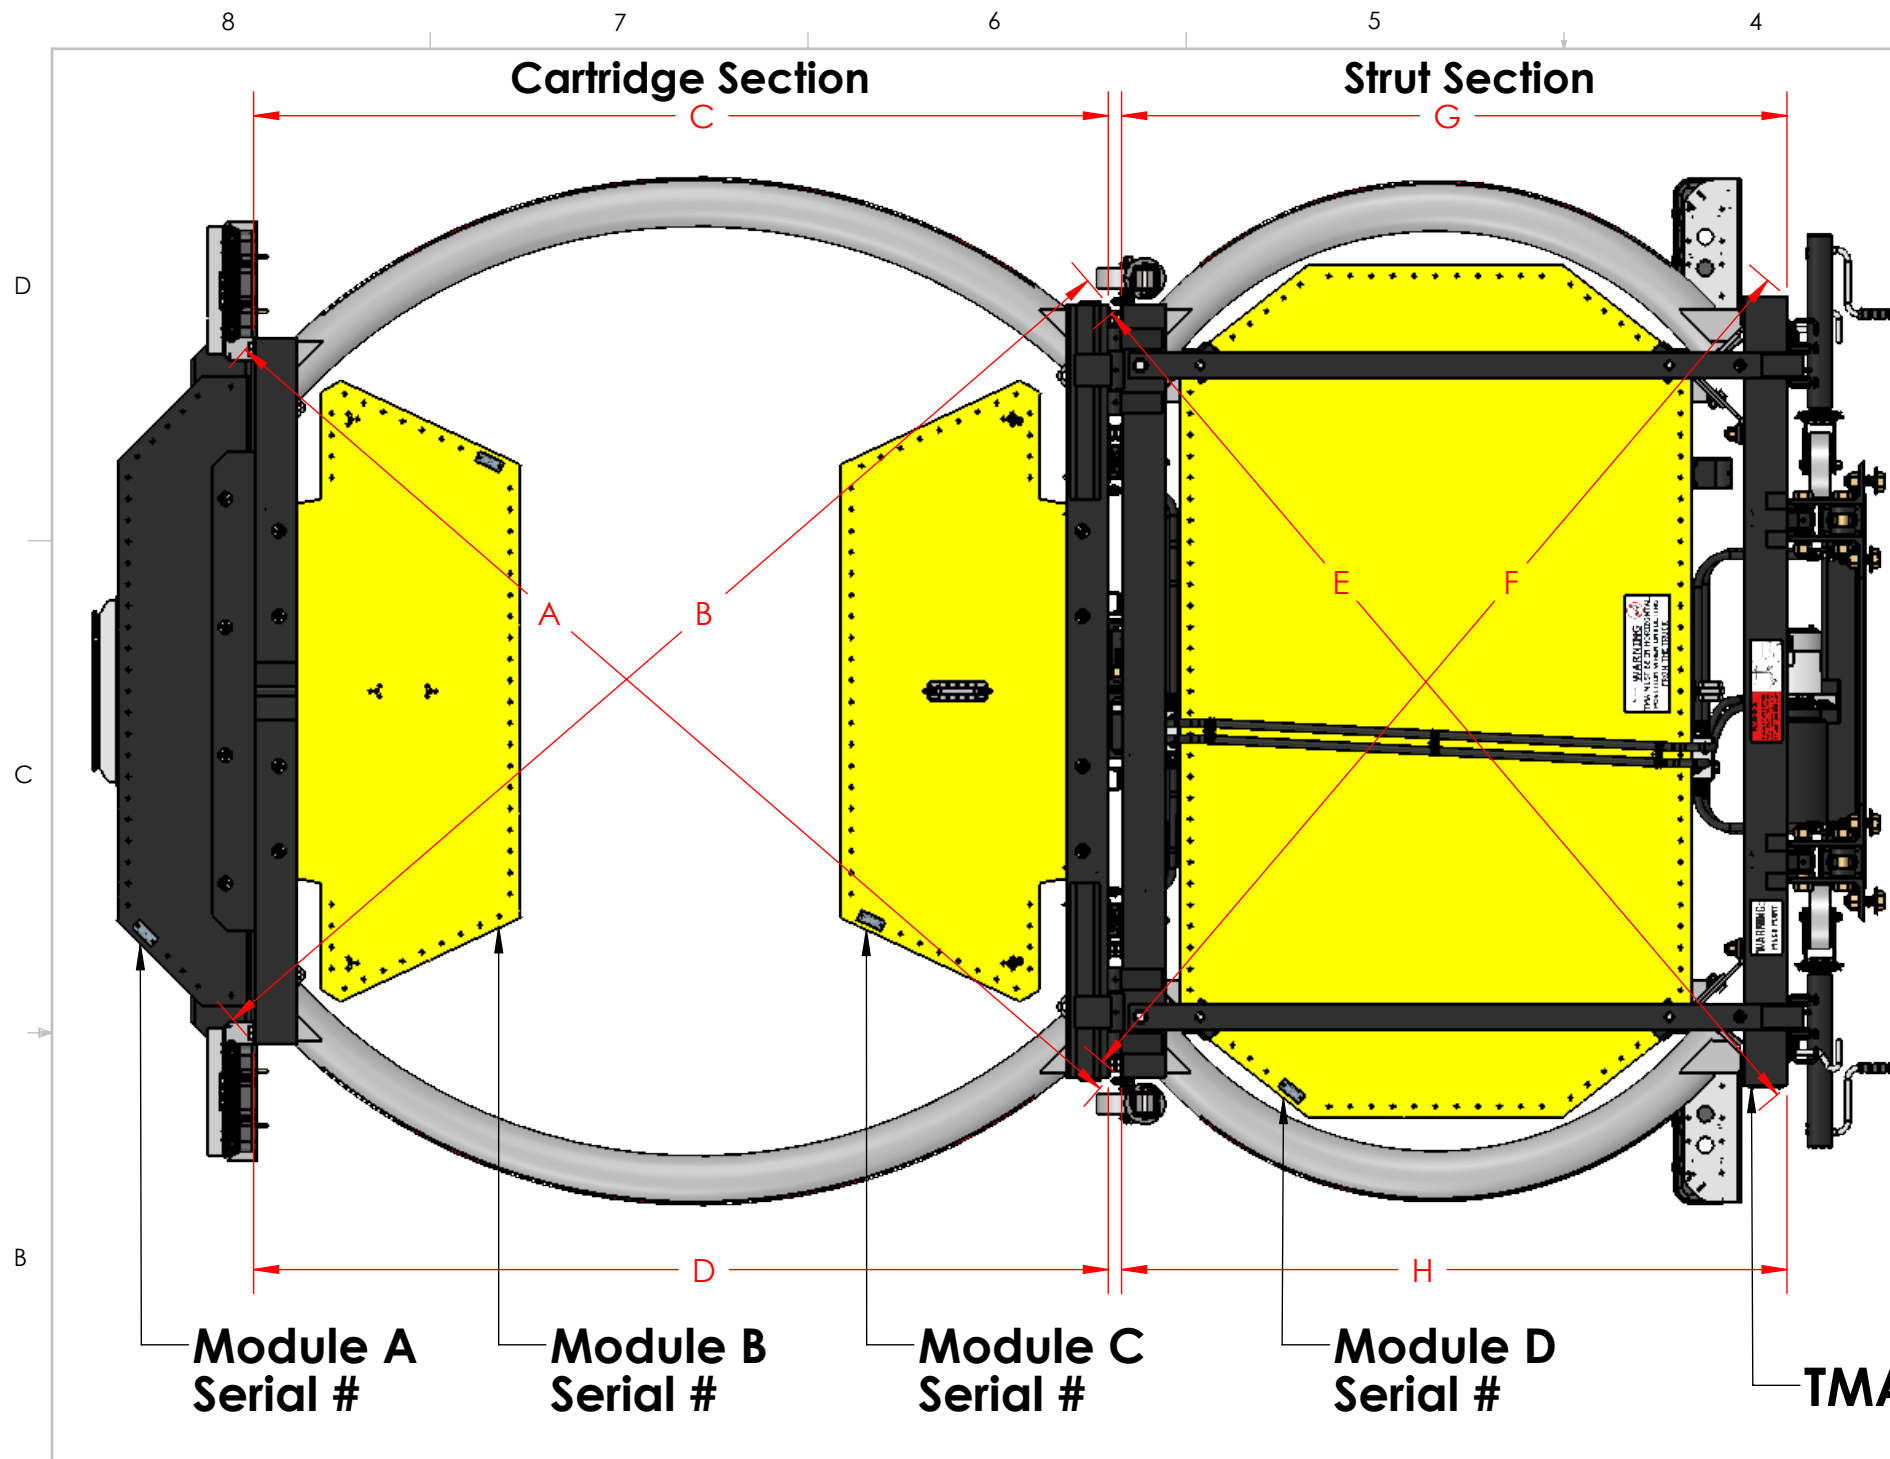
The purpose of the survey measurements is to determine whether or not the tube assemblies are still serviceable. Tube assemblies that are no longer in spec must be replaced before the TMA can be returned to service as a life saving piece of equipment.

A = _____

B = _____
As Built: 106" [2,692 mm]
Difference between A and B must be less than 1" [25 mm]

C = _____
Min: 79-3/4" [2,026 mm]
Max: 80-3/4" [2,051 mm]

D = _____
Min: 79-3/4" [2,026 mm]
Max: 80-3/4" [2,051 mm]

E = _____

F = _____
As Built: 96-1/4" [2,445 mm]
Difference between E and F must be less than 1" [25 mm]

G = _____
Min: 61-3/4" [1,569 mm]
Max: 62-3/4" [1,594 mm]

H = _____
Min: 61-3/4" [1,569 mm]
Max: 62-3/4" [1,594 mm]

- Record the TMA serial number and each energy absorbing module serial number in the spaces provided.
- Perform measurements A through H and record the values in the spaces provided.
- Dimension limits specified are valid for both NCHRP-350 tested Scorpion TMA and MASH tested Scorpion II TMA.
- All measurements must fall within the min/max values indicated for the tube assemblies to remain in service.
- If any measurements fall outside the acceptable limits, please consult with an appropriate TrafFix Devices representative.
- Any tube assemblies that are deemed "out of spec" must be destroyed by fully cutting the upper and lower tube.
- In some cases, it may be necessary to take measurements at the bottom as well as the top if damage is observed on the lower portion of the tube assemblies. Both top and bottom measurements must fall within the min/max values defined.

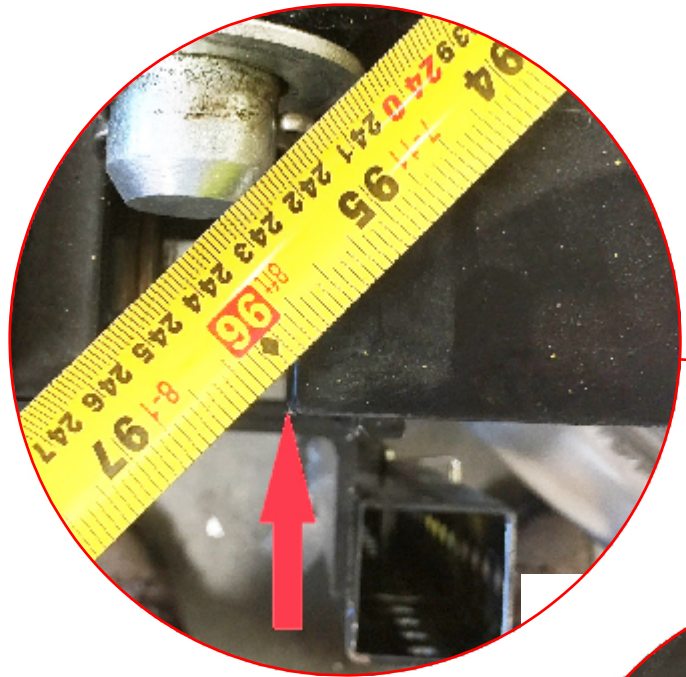
Strut Section: Survey Measurement Closeup Views

Closeup View of
Measurements E & F

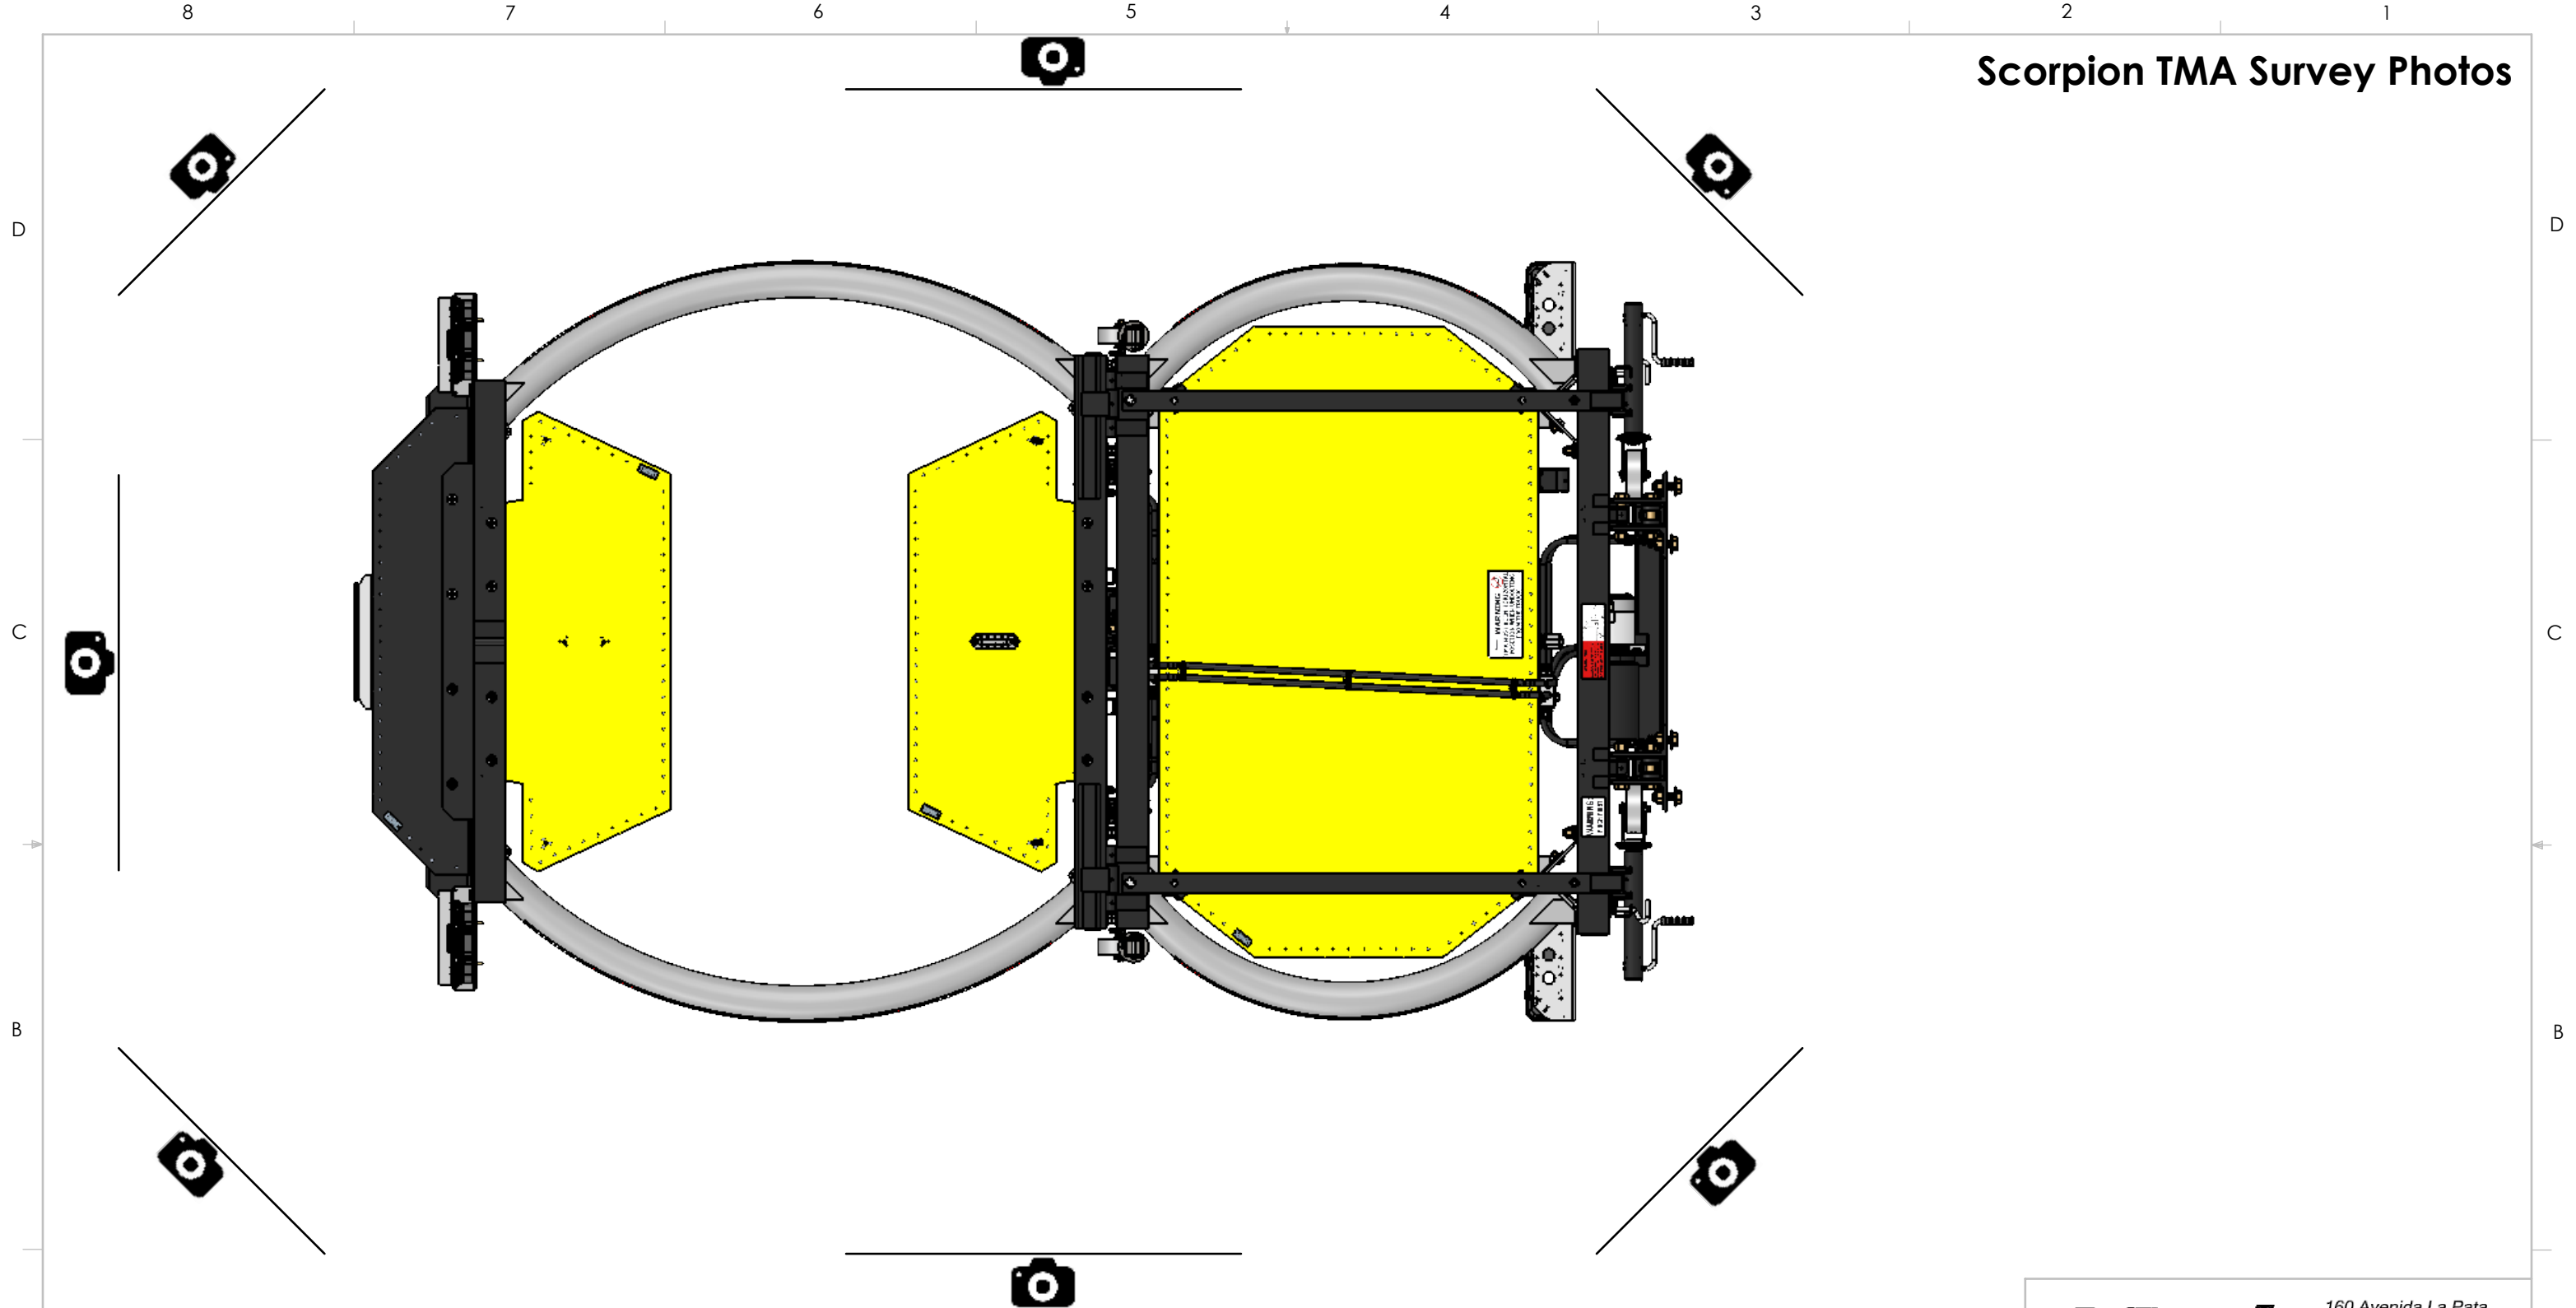
Scorpion TMA Survey Photos

Please provide photos of the TMA taken at the approximate angles shown. The views depicted are required at a minimum for Traffix Devices to assess the damage and make repair recommendations. If any gouges, indentations, or cracks on the tube assemblies are discovered during the inspection, closeup photos should be taken.

Closeup photos should also be provided of any damaged components that are observed during the visual inspection of the TMA.

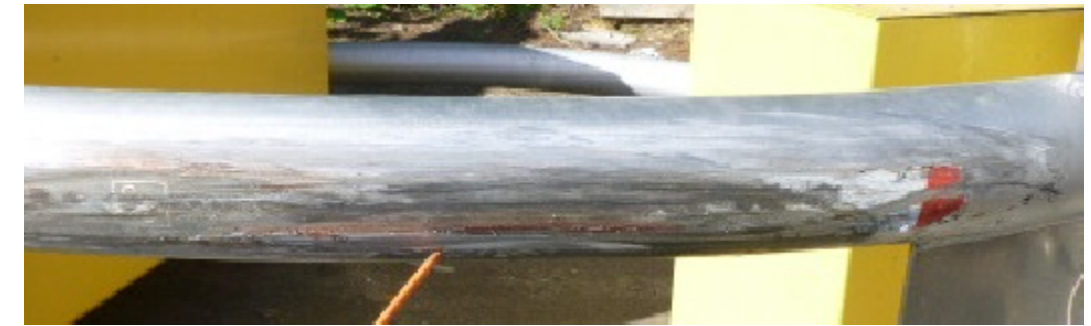
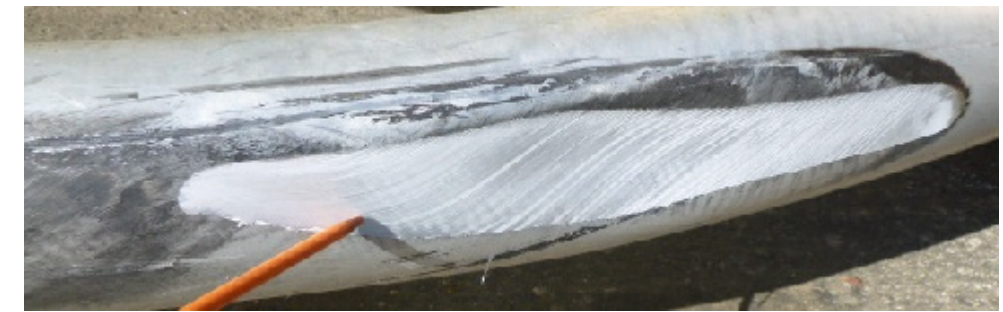
Examples of Tube Deformation

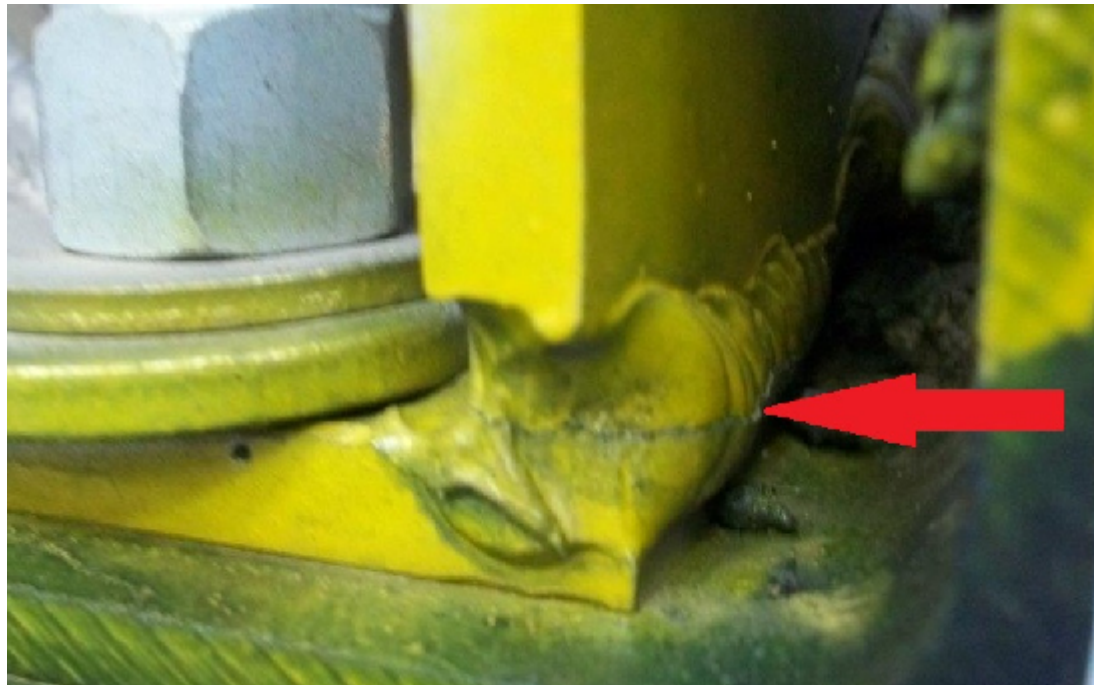
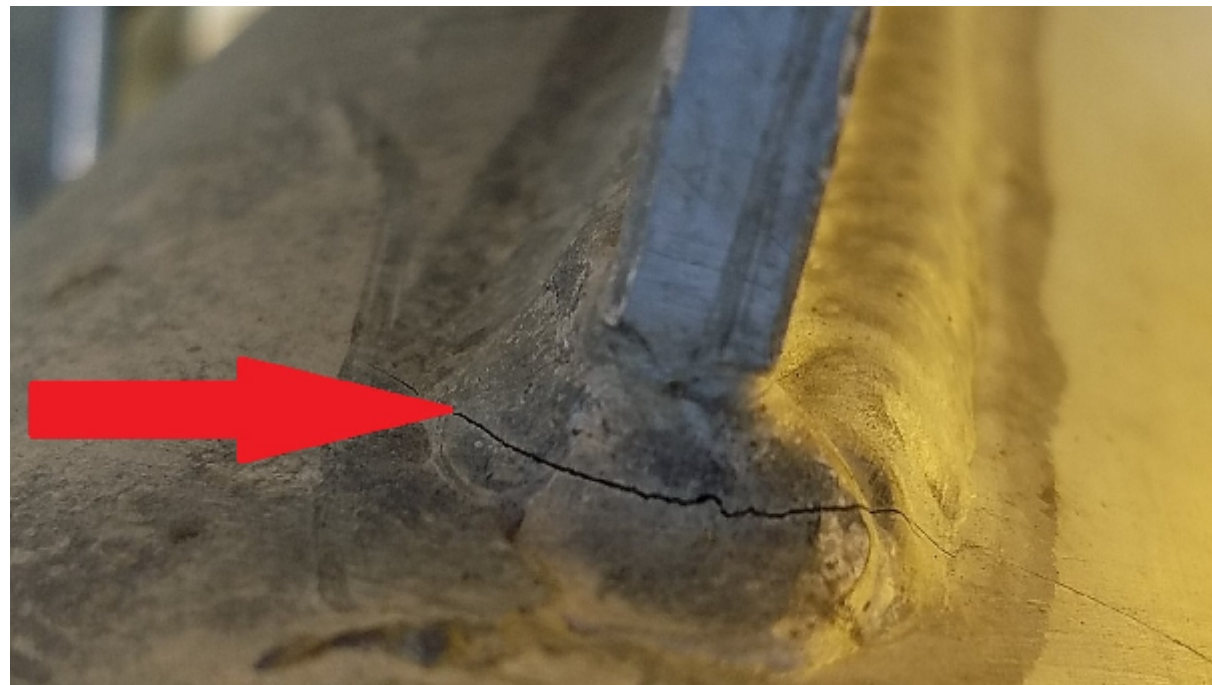
Examples of Cracks That Can Occur

Conduct a visual inspection of all welds on the strut and cartridge tube assemblies. Pay close attention to the areas outlined in red. Check for the presence of cracks in the welds and the tubes themselves. Inspect for any signs of material deformation such as gouges, chips, dents, or scrapes along the entire length of the top and bottom tubes.
